TEST REPORT

Report No. : BJ-R250618106A-EN

Test Item : High Temperature Test

Sample Name	Waterproof Speaker
Sample Model	AVS650MSP, AVS600MSP, AV400CS
Sample No.	BJ-R250618106A-1#~3#
Sample Size	/
Weight Of Sample	/
Sample Quantity	3 PCS
Manufacturer	SHENZHEN AVIS ELECTRONICS TECHNOLOGY CO.,LTD
Address	506-507A,HuiGu ChuangXin Technology park,JingBei road,Shiyan town,Baoan district,Shenzhen,Guangdong,China 518108
Sample Source	Commissioned units send sample
Inspection Type	Commissioning test
Sample Description	Sample appearance is good

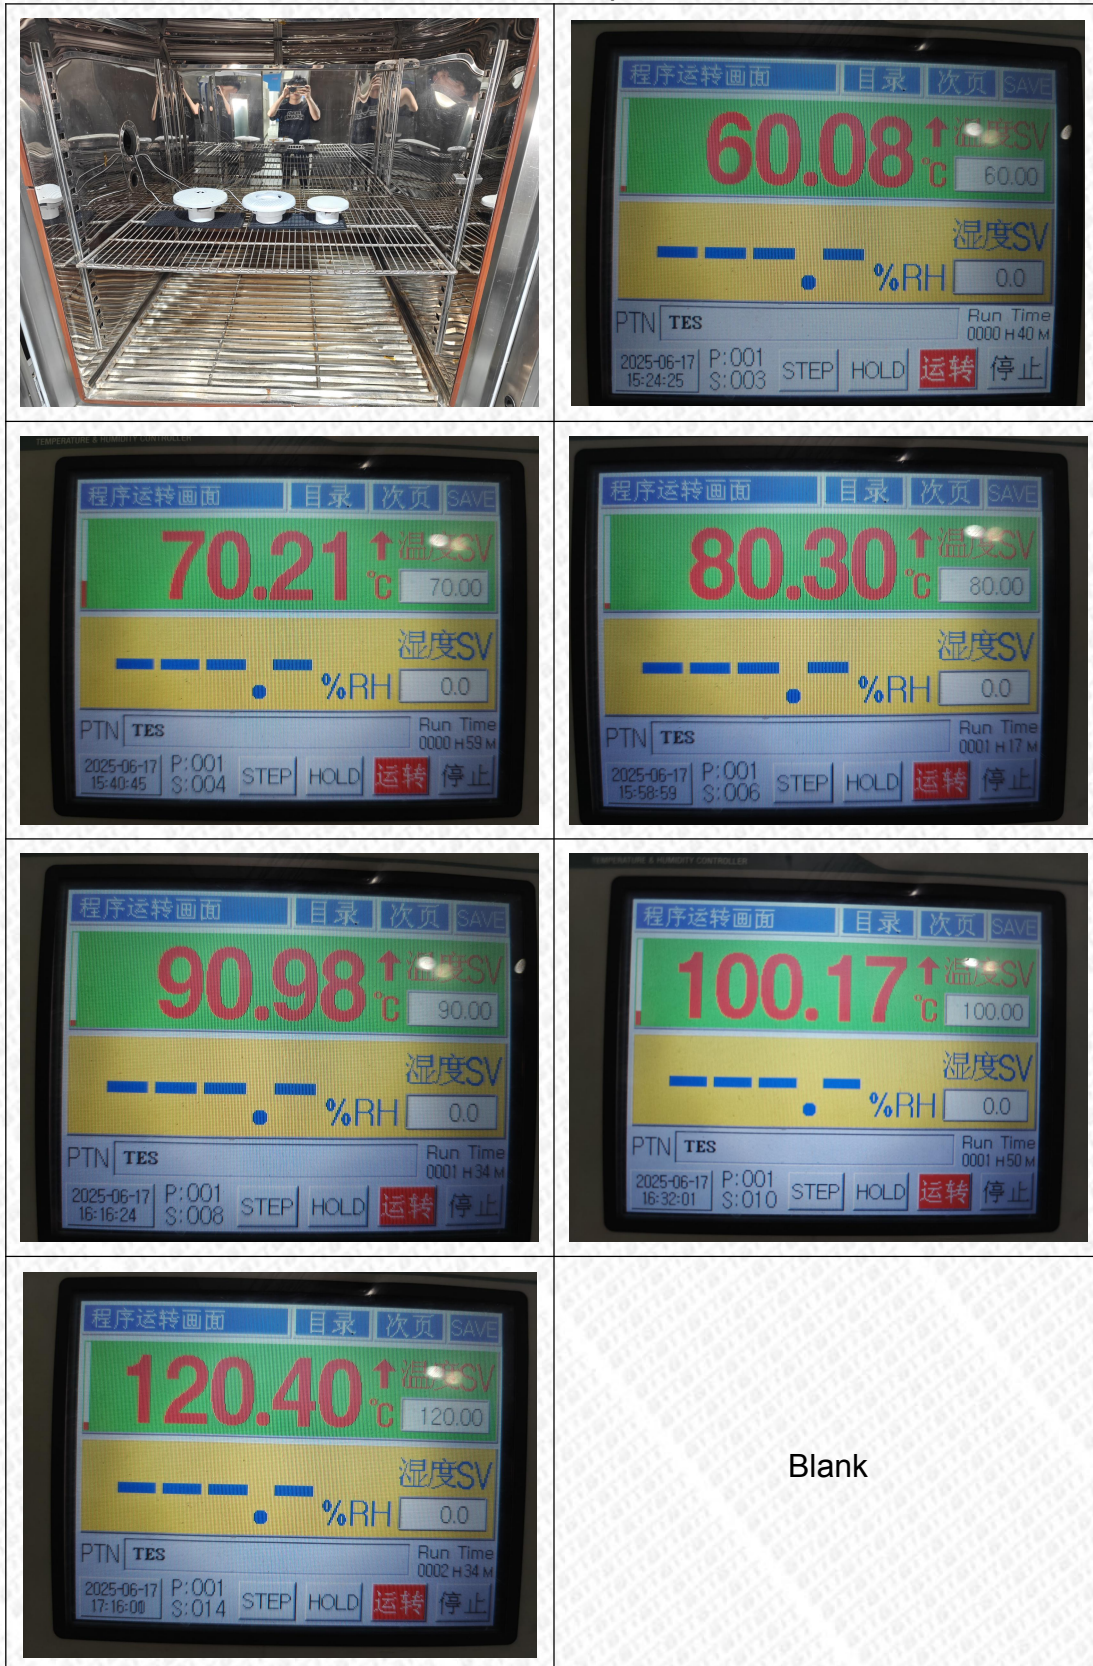
Test Equipment	Equipment Model	Calibration Date
Temperature & Humidity Test Chamber	QA-LP-100	Apr.08, 2025

Test setup

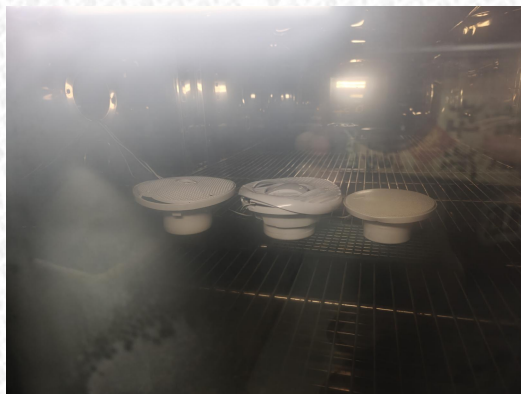
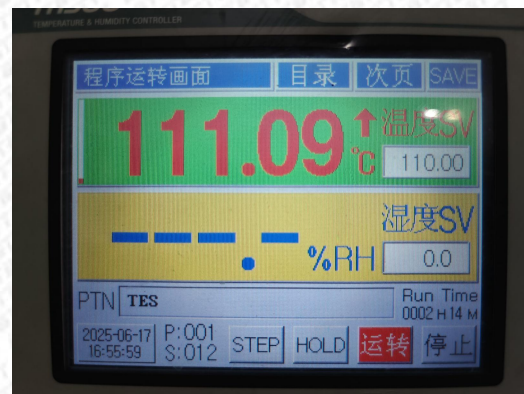
Abnormal changes during the test

Temperature, Time	Sample No.	Test Results
60℃ - working 10min	1# (AVS650MSP)	The appearance of the sample has no obvious change, and the function was normal.
	2# (AVS600MSP)	
	3# (AV400CS)	
70℃ - working 10min	1# (AVS650MSP)	The appearance of the sample has no obvious change, and the function was normal.
	2# (AVS600MSP)	
	3# (AV400CS)	
80℃ - working 10min	1# (AVS650MSP)	The appearance of the sample has no obvious change, and the function was normal.
	2# (AVS600MSP)	
	3# (AV400CS)	
90℃ - working 10min	1# (AVS650MSP)	The appearance of the sample has no obvious change, and the function was normal.
	2# (AVS600MSP)	
	3# (AV400CS)	
100℃ - working 10 min	1# (AVS650MSP)	The appearance of the sample has no obvious change, and the function was normal.
	2# (AVS600MSP)	
	3# (AV400CS)	
110℃ - working 10 min	1# (AVS650MSP)	The sample shows signs of melting, and the sound quality was impaired.
	2# (AVS600MSP)	The sample shows signs of melting, and the sound quality was impaired.

3# (AV400CS)	The sample has glue separation issues, and the sound quality was impaired.
120℃ - working 10 min	1# (AVS650MSP)	The sample shows signs of melting, and the sound quality was impaired.
	2# (AVS600MSP)	The sample shows signs of melting, and the sound quality was impaired.
	3# (AV400CS)	The sample has glue separation issues, and the sound quality was impaired.

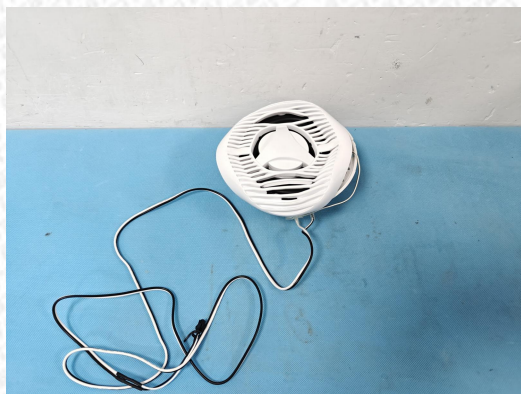
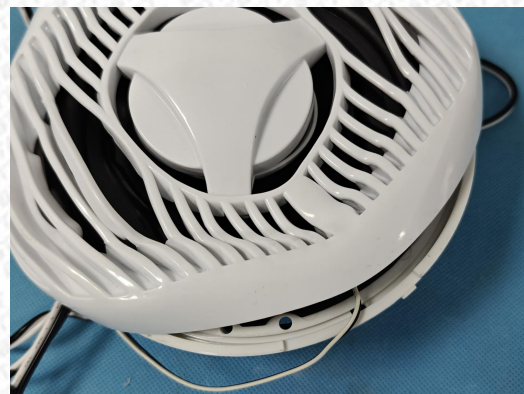
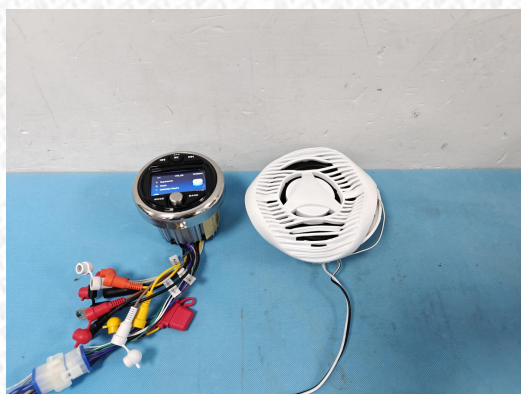
1# (AVS650MSP)

After test
